CQ Building & Pest Inspections Pty Ltd

ASBESTOS CONTAINING MATERIAL REGISTER **AND** **MANAGEMENT PLAN**

IN ACCORDANCE WITH WORKPLACE HEALTH & SAFETY QUEENSLAND
CODE OF PRACTICE – 2011
HOW TO MANAGE AND CONTROL ASBESTOS

Single Storey Steel Frame and Fibro Clad Dwelling.

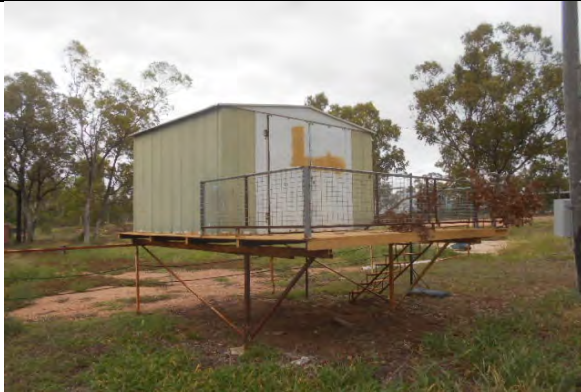
OUTBUILDING 1

Description: METAL GARDEN SHED/KIDS CUBBY

DOES NOT CONTAIN ASBESTOS

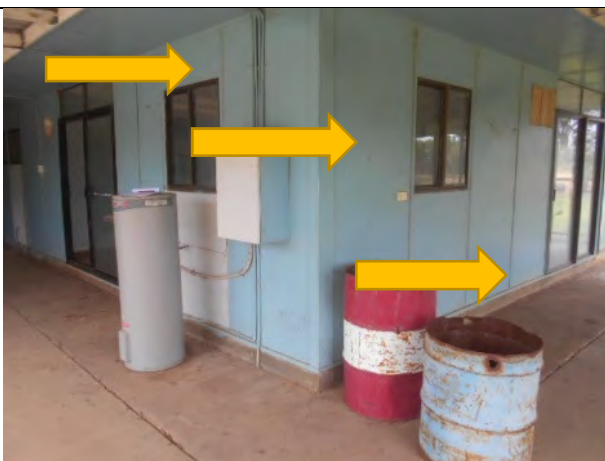
Photo 001

LOCATION	TYPE OF MATERIAL/ PRODUCT	PHOTO NUMBER:	TESTED	CONDITION	PRIORITY LEVEL
All External Fibro Wall Sheeting/Material to main House only <i>See sample 1</i>	FIBRO	001, 002, 003	YES	MINOR DAMAGE	MEDIUM
Mouldings/Cover strips to Amenities Block at rear	FIBRO	004, 005	NO	MINOR DAMAGE	MEDIUM
Soffit / Eaves / Overhangs Sheeting/Material to main House	FIBRO	006, 007, 008	NO	GOOD	LOW

<u>LOCATION OF ASBESTOS CONTAINING MATERIALS</u>				
HOUSE				
<i>LOCATION</i>	<i>TYPE</i>	<i>PHOTO NUMBER</i>	<i>CONDITION</i>	<i>PRIORITY</i>
All External Fibro Wall Sheeting/Material to main House only	FIBRO	001, 002, 003	MINOR DAMAGE	MEDIUM
Soffit / Eaves / Overhangs Sheeting/Material to main House only	FIBRO	006, 007, 008	GOOD	LOW
Internal Wall & Ceiling Sheeting/Material (not including Wall Sheeting/Material to front entry/enclosed Patio area)	FIBRO	009, 010, 011, 012, 013, 014	GOOD	LOW
AMENITIES BLOCK				
<i>LOCATION</i>	<i>TYPE</i>	<i>PHOTO NUMBER</i>	<i>CONDITION</i>	<i>PRIORITY</i>
Mouldings/Cover strips to External Walls	FIBRO	004, 005	MINOR DAMAGE	MEDIUM

- All asbestos containing materials (fibro sheeting/material) must be maintained in good sealed/ painted condition at all times, so as to prevent asbestos fibres becoming airborne and reducing the risk of asbestos poisoning.
- Repair/replace all damaged Fibro Sheeting to House immediately.

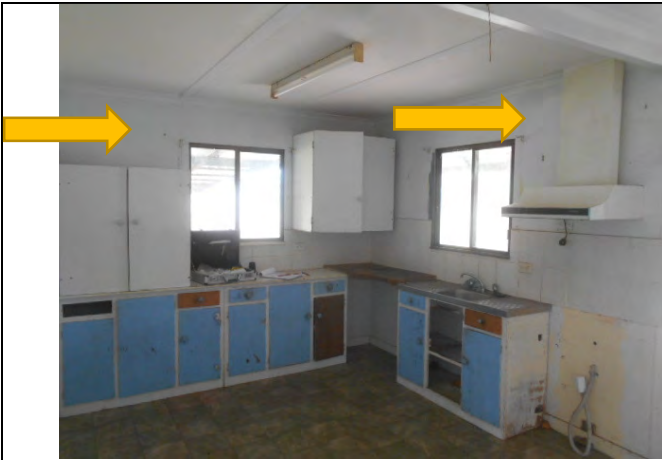
Photo 011

LOCATION	TYPE OF MATERIAL/ PRODUCT	PHOTO NUMBER:	TESTED	CONDITION	PRIORITY LEVEL
Wall Sheeting/Material to House (not including front entry/enclosed Patio area) <i>See sample 4</i>	FIBRO	009, 010, 011, 012	YES	MINOR DAMAGE	MEDIUM
Ceiling Sheeting/Material throughout House	FIBRO	013, 014	NO	GOOD	LOW

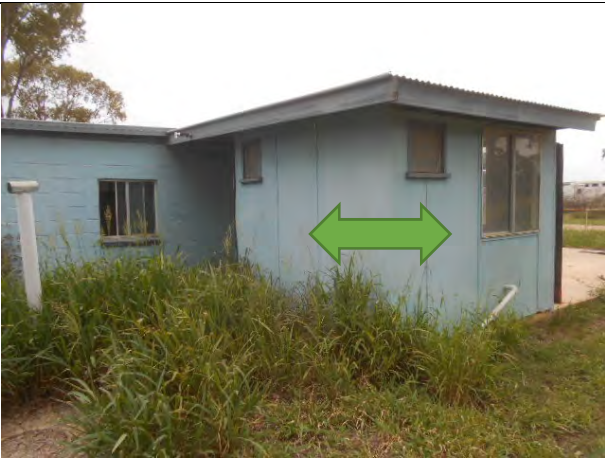
Photo 015

<i>LOCATION</i>	<i>SAMPLE NUMBER</i>	<i>TYPE</i>	<i>PHOTO NUMBER</i>
External Wall Sheeting (not including Cover Strips)	2	Fibro	015, 016
Internal Wall Sheeting	3	Fibro	017, 018, 019
