CQ Building & Pest Inspections Pty Ltd

VISUAL TIMBER PEST INSPECTION & REPORT

In accordance with A.S. 4349.3-2010

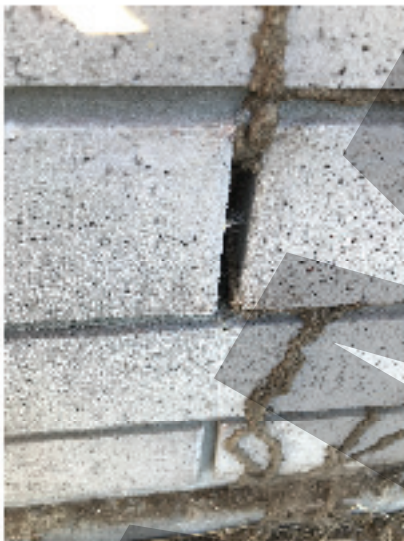
- Active Termites visible to outside front main Bedroom wall.
- (see photos below).

Example of active Termites to front wall of House.

Note: Where active Termites are found, we recommend immediate treatment and/or further investigation.

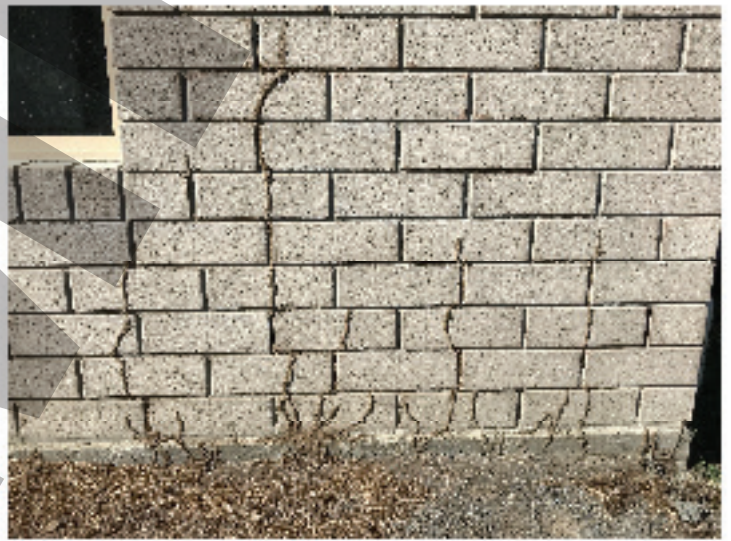
Example of active Termites to front wall of House.

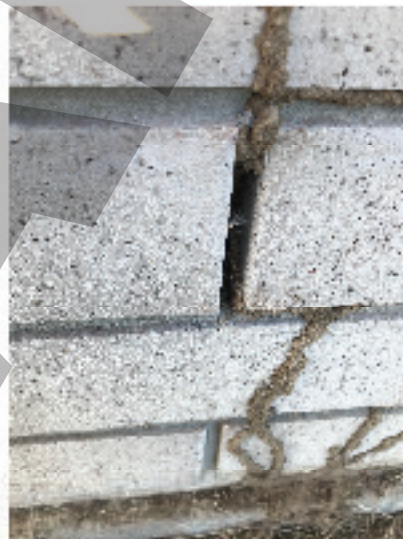
Example of active Termite workings leading into wall cavity.

- Wall forming to front Bedroom walls, active Termite trackings on outside masonry walls leading into wall cavity through weep holes, remove inside wall sheathing adjacent to Termite tracking to reveal any concealed Termite damage.
- (see photos below).
