# CQ Building & Pest Inspections Pty Ltd

## VISUAL TIMBER PEST INSPECTION & REPORT

In accordance with A.S. 4349.3-2010

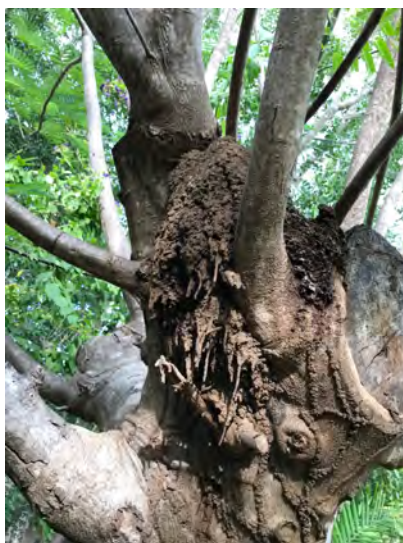
- Yes

- Logs/Stumps/Sleepers/Timbers throughout the yard.
- Surrounding trees.

- ✓ **Schedorhinotermes**  
This genus is at times just as destructive as the Coptotermes species and is found throughout mainland Australia but mostly Eastern Mainland, Nests are usually down low in Stumps and under Patios or under Houses etc.
- ✓ **Heterotermes**  
This genus is not usually considered a destructive species, however, in some cases if left unattended damage can occur. They do not build mounds and are usually found adjacent to other Termite species in Logs, Stumps etc.
- ✓ **Microcerotermes**  
This genus can cause structural damage, but is rare as they usually are found in posts, fences, stumps and decaying wood and are found throughout mainland Australia.

Example of Termite nest in front yard.

**Note:** Where active Termites are found, we recommend immediate treatment and/or further investigation.

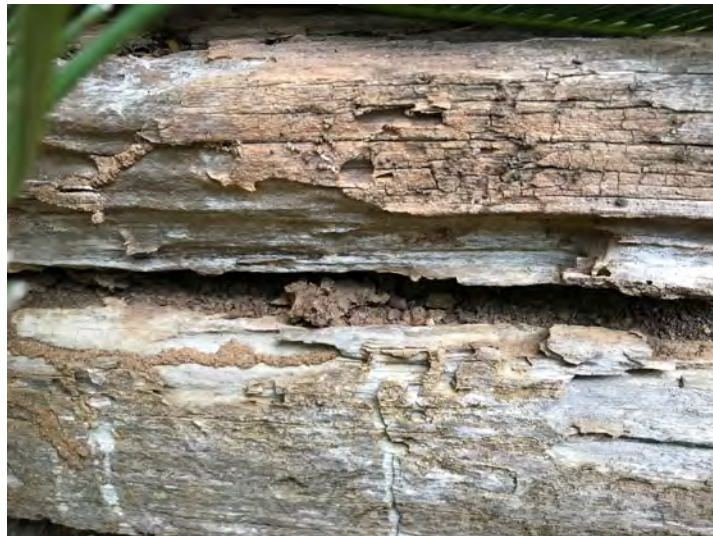
- A few fence posts.
- Logs/Stumps/Sleepers to yard.
- Timber retaining walls.
- (see photos below).

Example of Termite damaged logs/sleepers/Timbers in yard.
