CQ Building & Pest Inspections Pty Ltd

ASBESTOS CONTAINING MATERIAL REGISTER **AND** **MANAGEMENT PLAN**

IN ACCORDANCE WITH WORKPLACE HEALTH & SAFETY QUEENSLAND
CODE OF PRACTICE – 2011
HOW TO MANAGE AND CONTROL ASBESTOS

Single Storey Steel Frame and Fibro Clad Dwelling.

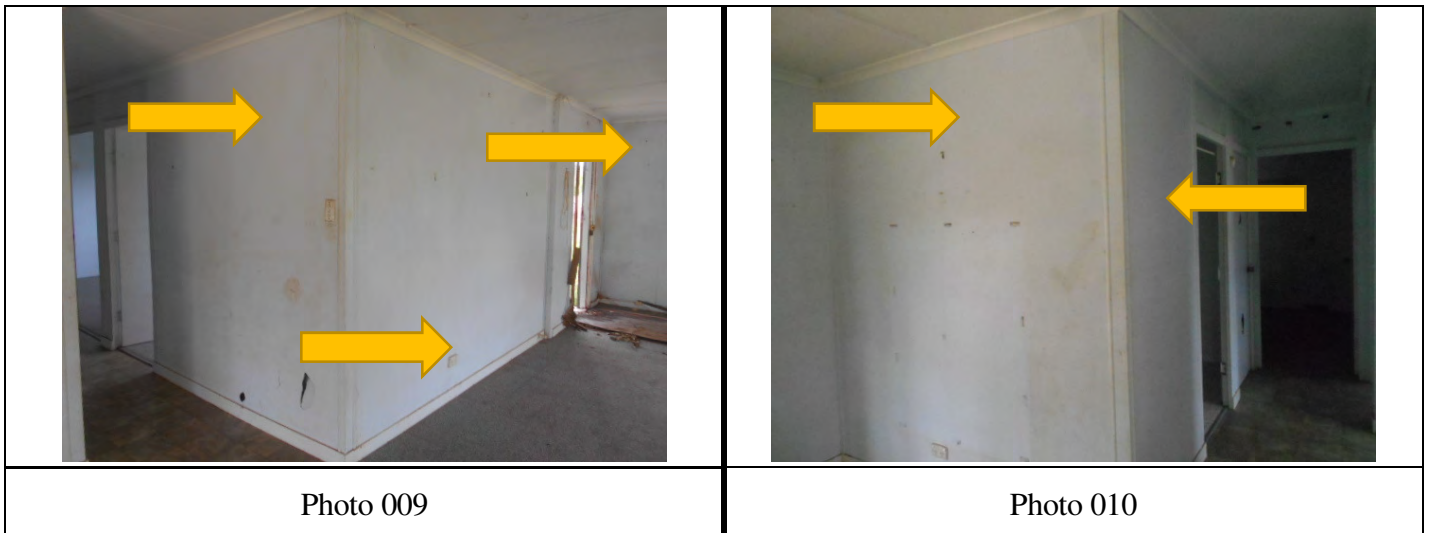
LOCATION	TYPE OF MATERIAL/ PRODUCT	PHOTO NUMBER:	TESTED	CONDITION	PRIORITY LEVEL
Wall Sheeting/Material to House (not including front entry/enclosed Patio area) <i>See sample 4</i>	FIBRO	009, 010, 011, 012	YES	MINOR DAMAGE	MEDIUM
Ceiling Sheeting/Material throughout House	FIBRO	013, 014	NO	GOOD	LOW
